# BELZONA FULLY SEALS FLANGE BETWEEN KAPLAN TURBINE AND SPIRAL CASING

Customer Location: Hydropower Station, Aschbach, Austria  
Application Date: July/August 2010

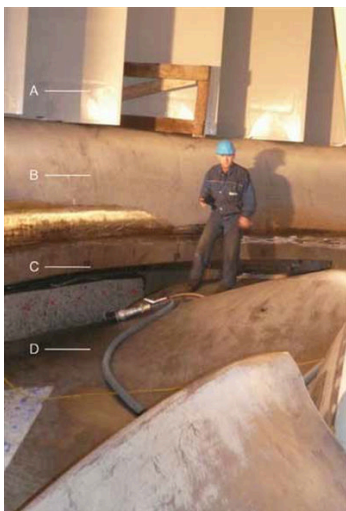
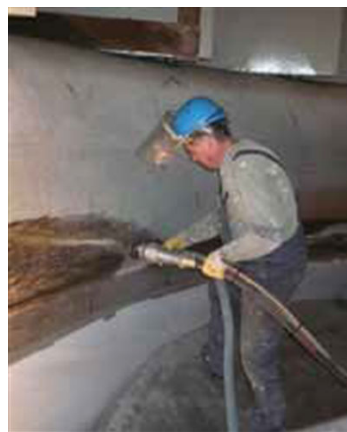
A new larger turbine runner, which has recently been built to increase the turbine output, required the installation of a new turbine casing that required welding. The heat generated from this process caused the turbine casing to become distorted and a circumferential gap of between 2.8 mm to 4.6 mm appeared between the two mating flanges.

- \* View of the Kaplan Turbine; A) stay vanes, B) spiral casing, C) circumferential gap, D) turbine runner output, 85 MW ,
- \* Surface preparation with the dust-free vacu-blast system ,
- \* Tape used to prevent overflow and to ensure gap was fully injected with Belzona 2131 ,
- \* Completed repair with Belzona 2131 on inside section of gap ,

The surface in and around the gap was prepared by grit blasting to ensure a minimum profile depth of 90 microns. The next step was to insert a foam backer rod into the gap to prevent Belzona 2131 from flowing into the outer section. In order to achieve the best adhesion possible, the surfaces had to be pre-treated with Belzona 2941. The injection nozzle was elongated with a flexible straw to ensure that Belzona 2131 could be injected into even the smallest area. The injection method was carried out and after cure, which in this case needed three-and-a-half days, the tape was removed and Belzona 2131 was faired level to the metal surface. The outer gap was then prepared for the injection of Belzona 1321. 96 bolt holes were injected with Belzona 1321 and the edge was then sealed with Belzona 1111 to ensure no overflow would occur. The bolt was treated with Belzona 9411 which ensured that the bolt could be removed easily after curing. Once fully cured, the release agent bolts were replaced by the originals and the flanges could be mated together without unnecessary stressing and the casing joint was now fully sealed.
