# BELZONA SAVES THE BULL GEAR

ID: 5924

Industry: *Mining & Quarrying*  
Application: *MPT-Mechanical Power Transmission*

Ore processing Ball Mill bull gear.

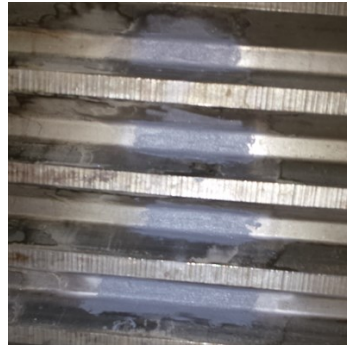
*The gears on this Ball Mill bull gear were experiencing erosion and pitting.*

If unchecked, the erosion damage could have weakened the bull gear, forcing the need to replace it. There are a total of 5 of these gears with damage and they were manufactured in the 1960's. The replacement cost is estimated at \$150,000.00 USD each and

The application area was thoroughly cleaned with solvent and then grit blasted to prepare the surface. All erosion damage was filled in with Belzona 1111 and followed with a brush on coating of Belzona 1321 to protect against further damage.
