# Ремонт двигателя РЕНО 5000

ID: 5968

Заявление: ENC-Engines and Casings

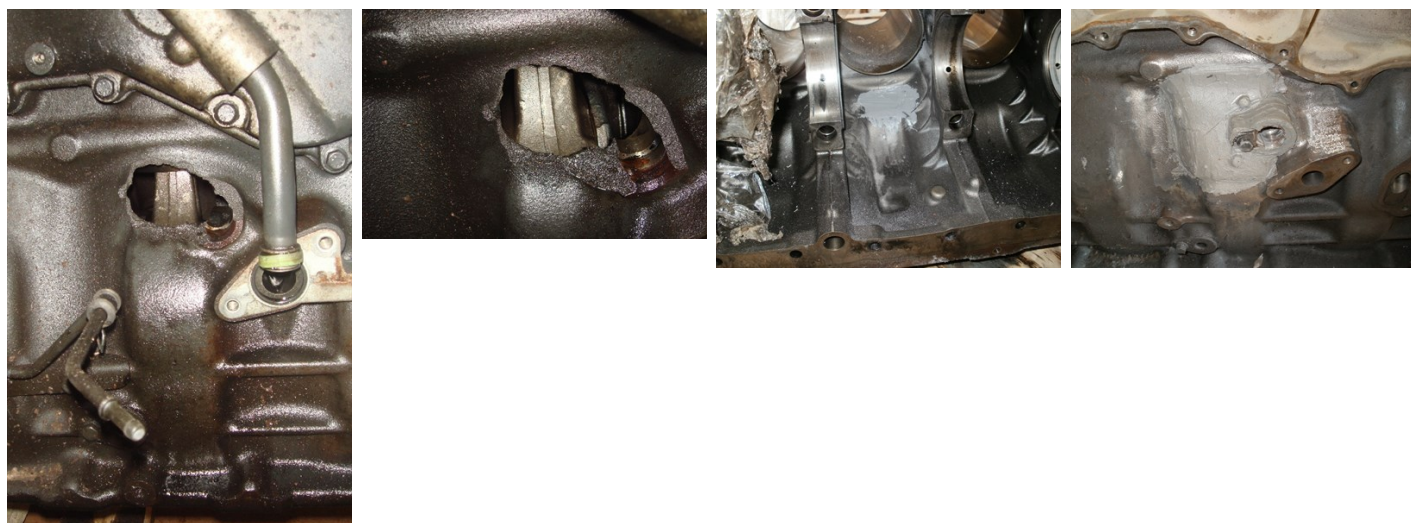
Эксплуатация двигателя с отверстием в блоке цилиндров невозможна. Требуется покупка нового блока.

\* 1. Общий вид повреждения 2. Повреждение крупным планом 3. Заделанное отверстие вид изнутри 4. Заделанное отверстие вид снаружи ,

При эксплуатации двигателя большегрузного автомобиля произошел срыв шатуна рабочего цилиндра. При этом возникло сквозное отверстие в блоке цилиндров.

Для возврата в строй двигателя было необходимо купить новый блок цилиндров. Применение материалов и технологии Belzona позволило уменьшить расходы на восстановление двигателя в несколько раз. На сегодняшний день замечаний нет.
