Ремонт двигателя РЕНО 5000

ID: 5968

Заявление: ENC-Engines and Casings

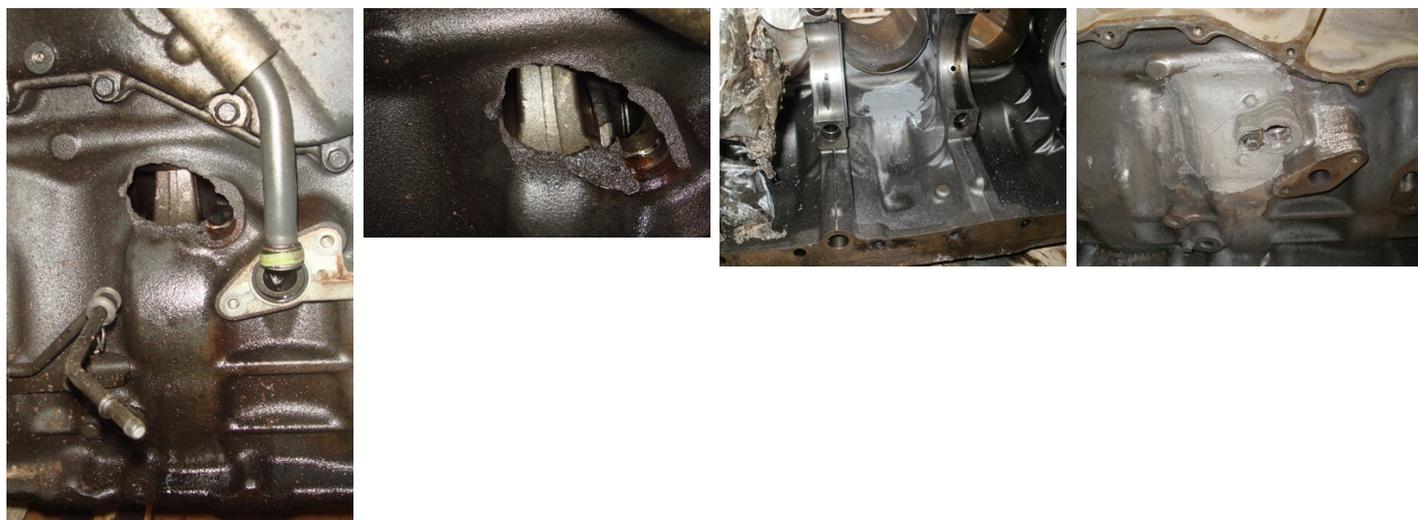
Эксплуатация двигателя с отверстием в блоке цилиндров невозможна. Требуется покупка нового блока.

* 1. Общий вид повреждения 2. Повреждение крупным планом 3. Заделанное отверстие вид изнутри 4. Заделанное отверстие вид снаружи ,

При эксплуатации двигателя большегрузного автомобиля произошел срыв шатуна рабочего цилиндра. При этом возникло сквозное отверстие в блоке цилиндров.

Для возврата в строй двигателя было необходимо купить новый блок цилиндров. Применение материалов и технологии Belzona позволило уменьшить расходы на восстановление двигателя в несколько раз. На сегодняшний день замечаний нет.
