Ремонт двигателя РЕНО 5000

ID: 5968

Продукты: ** Belzona 1111 ,*

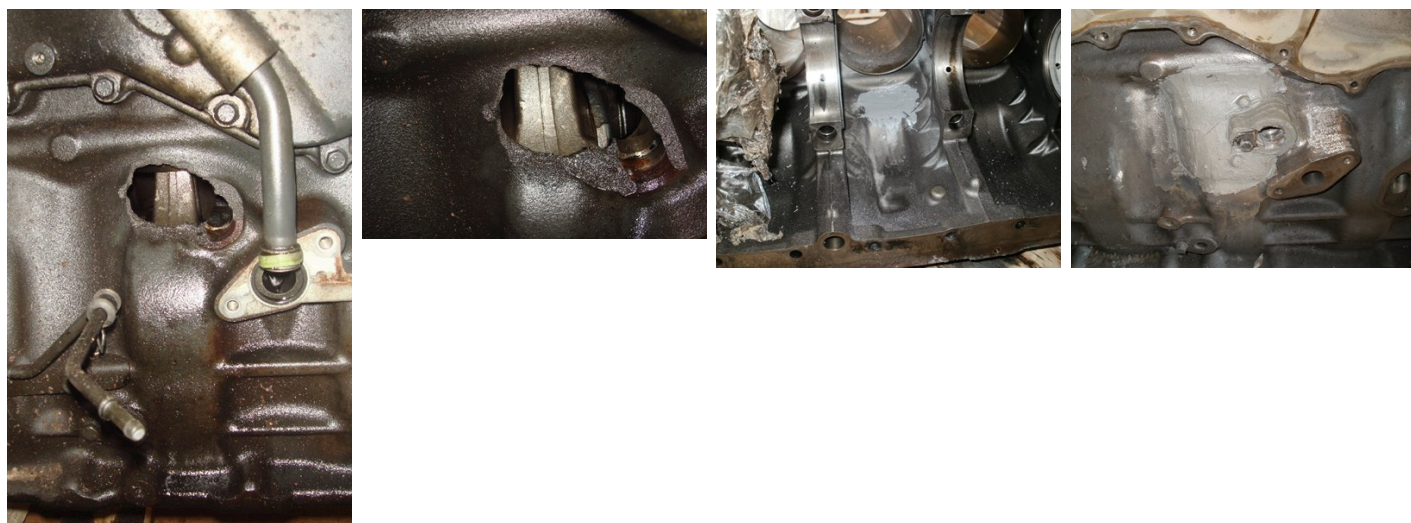
Описание фотографий

Эксплуатация двигателя с отверстием в блоке цилиндров невозможна. Требуется покупка нового блока.

* 1. Общий вид повреждения 2. Повреждение крупным планом 3. Заделанное отверстие вид изнутри 4. Заделанное отверстие вид снаружи ,

При эксплуатации двигателя большегрузного автомобиля произошел срыв шатуна рабочего цилиндра. При этом возникло сквозное отверстие в блоке цилиндров.

Для возврата в строй двигателя было необходимо купить новый блок цилиндров. Применение материалов и технологии Belzona позволило уменьшить расходы на восстановление двигателя в несколько раз. На сегодняшний день замечаний нет.
