CENTRIFUGAL PUMP REPAIRED AT A FRACTION OF THE COST OF REPLACEMENT

ID: 6034

Customer Location: Louisiana, USA
Application Date: July, 2015

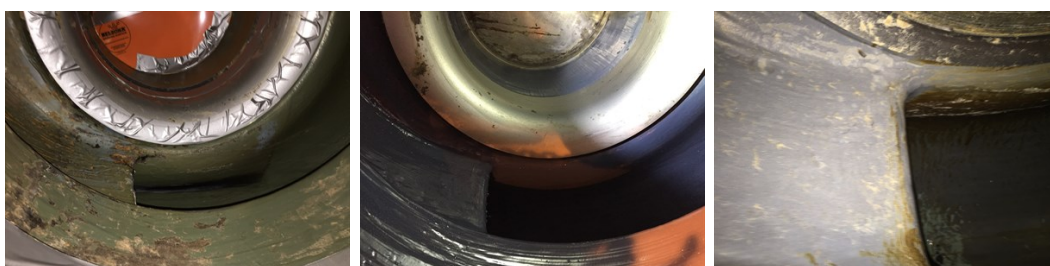
Badly damaged pump casing internals with pitting could not be removed and replaced or put back in service.

- * Corroded and damaged pump before application. ,
- * Pump casing coated with Belzona 1331. ,
- * Pump casing seven months after the application. This time instead of coating or replacing, the plant inspected and returned to service with little to no down time. ,

The application was carried out in accordance with a modified version of the Belzona Know-How System Leaflet CEP-5.

In the past the pump casing would be scrapped and replaced at a cost of \$36,000, providing only three to six months of service. The Belzona repair cost \$10,000, saving \$26,000 in replacement costs and preventing extra downtime in the future.
