CENTRIFUGAL PUMP REPAIRED AT A FRACTION OF THE COST OF REPLACEMENT

ID: 6034

Industry: *General Industry*
Application: *CEP-Centrifugal Pumps*
Substrate: *Cast Iron*
Products: ** Belzona 1111 (Super Metal) ,*
** Belzona 1331 ,*

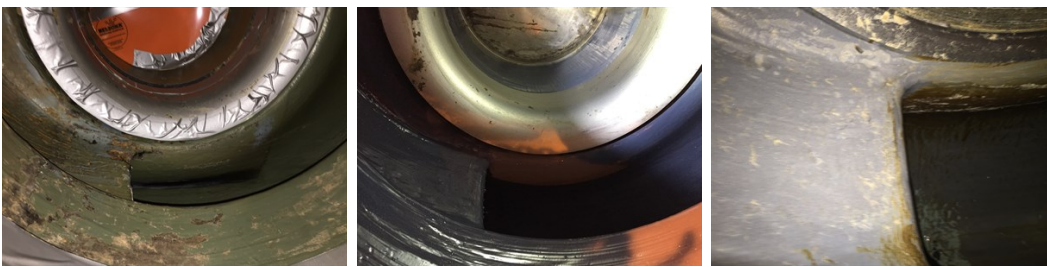
Badly damaged pump casing internals with pitting could not be removed and replaced or put back in service.

- * Corroded and damaged pump before application. ,
- * Pump casing coated with Belzona 1331. ,
- * Pump casing seven months after the application. This time instead of coating or replacing, the plant inspected and returned to service with little to no down time. ,

The application was carried out in accordance with a modified version of the Belzona Know-How System Leaflet CEP-5.

In the past the pump casing would be scrapped and replaced at a cost of \$36,000, providing only three to six months of service. The Belzona repair cost \$10,000, saving \$26,000 in replacement costs and preventing extra downtime in the future.
