PRESS ROLL CRACK REPAIR WITH BELZONA

ID: 616

Industry: *Pulp & Paper*
Application: *SHM-Solids Handling Machinery*

Customer Location: *Pulp and paper mill, Egypt*
Application Date: *December 2004*

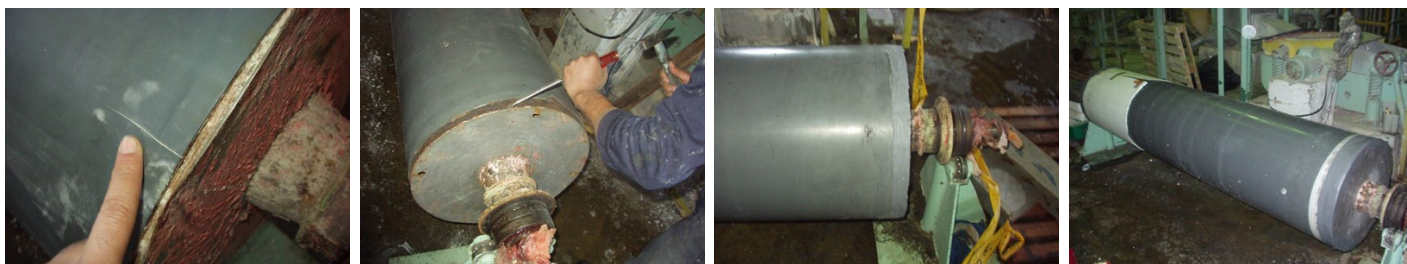
Crack in the hard rubber cover of the press roll. The crack was increasing over time.

- * The crack in the rubber cover ,
- * Removing the cracked layer ,
- * Belzona® 1111 applied to the roll ,
- * Completed repair ,

Application was carried out in accordance with Belzona Know-How System Leaflet SHM-9. The cracked layer was removed then Belzona® 1111 applied and finally machined back to size.
