BELZONA SEALS BROKEN SKYLIGHTS

Industry: Buildings & Structures
Application: RPA-Roof Problem Areas
Substrate: Bitumen
Products: * Belzona 3111 (Flexible Membrane) ,

Customer Location: Office building, Bielsko-Biala, Poland
Application Date: July 2009

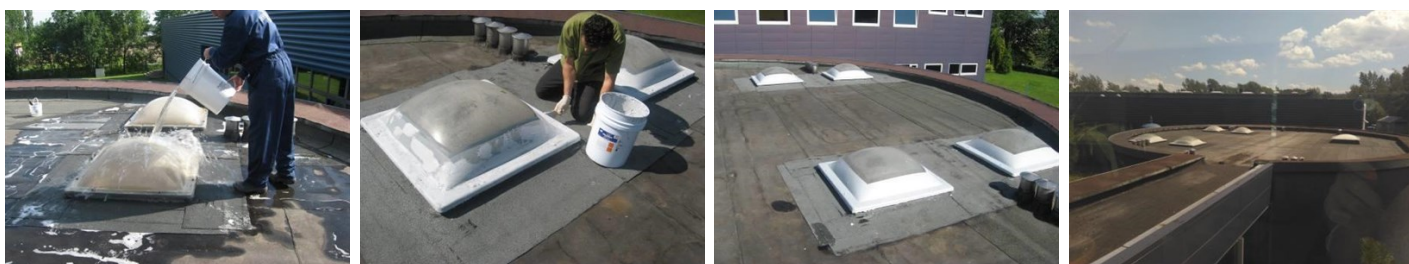
Under the influence of the sun skylights had broken around the fastening bolts allowing leakage of water into the rooms below whenever it rained.

* 1. Washing damaged skylights 2. Application of Belzona 3111 onto the Belzona 3911 Conditioner 3. Rooftop view immediately after the repair. 4. Rooftop view August 2016 ,

Application was carried out in accordance with Belzona Know-How System Leaflet RPA-3.

Repair cost less than half the purchase and replacement costs of new skylights. Inspected in August 2016 repairs still in excellent condition and keeping offices dry.
