BELZONA SAVES CAST IMPELLER FROM SCRAP

ID: 6423

New cast iron impeller slurry pump

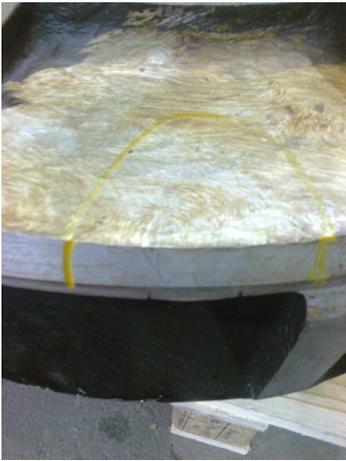
Set of cracks on one side of the newly cast impeller. The end-user had refused to accept the impeller without elimination of the cracked area. After mutual agreement between the customer and end-user, they agreed that a Belzona solution could be used.
