Belzona Rebuilds Shaft During Wind Turbine Maintenance

ID: 6437

Industry: *Power*Customer Location: *Wind farm, Central Sweden*Application: *MPT-Mechanical Power Transmission*Application Date: *May 2011*Substrate: *Steel*Products: ** Belzona 1131 (Bearing Metal),*

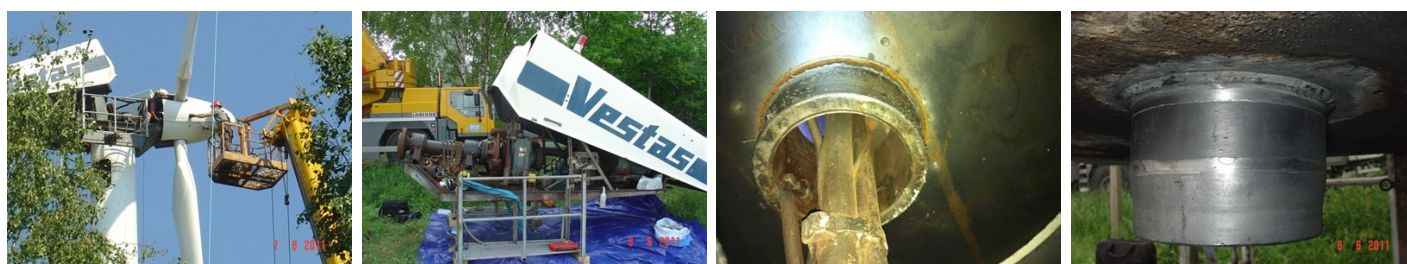
Inspection revealed that the nacelle had suffered from water ingress and the yaw drive shaft was experiencing damage due to corrosion and wear due to lack of lubrication.

- * 1. Crane access required to maintain the nacelle ,
- * 2. Nacelle removed for routine inspection and maintenance ,
- * 3. Corroded shaft ,
- * 4. Shaft rebuilt using self-lubricating Belzona 1131 ,

Application was carried out in accordance with Belzona System Leaflet MPT-2. A former was used to mould Belzona 1131 to correct dimensions.

Belzona 1131 possesses self-lubricating properties for creation of low friction surfaces in the event of lubrication loss. The product is also corrosion resistant. This made it the ideal solution for the shaft repair. This application is still in service as of 2017.
