BELZONA REPAIRS OIL LEAKS ON WIND FARM TRANSFORMER

ID: 7535

Customer Location: Ireland
Application Date: September 2017

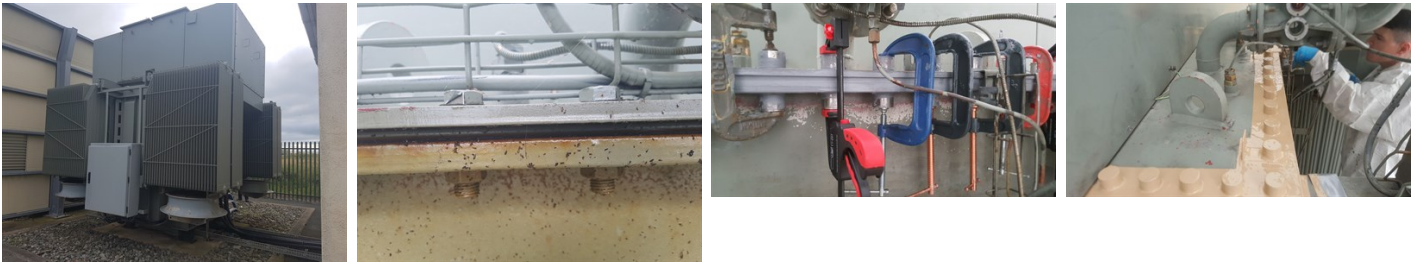
- * 1. General view of the transformer ,
- * 2. Leaking oil on the flange ,
- * 3. Flange face filled with Belzona 1161 and caps installed ,
- * 4. Completed section ,

Transformer for a wind farm was leaking oil through the main flange and flange bolt holes. Approximately 120 bolts were leaking.

Application was carried out in accordance with a modified version of Belzona Know-How System Leaflet GSS-8. Stainless steel caps were fabricated to fit over the bolt heads and the nuts. The gap in between the transformer body and the top cover was filled with Belzona 1161. The caps were filled with Belzona 1161 and clamped onto the bolt heads and nuts. The repair was coated with Belzona 5811
