Belzona repairs damaged turbine flange face

Customer Location: *Chemical plant, Slovakia*

Application: *ENC-Engines and Casings*

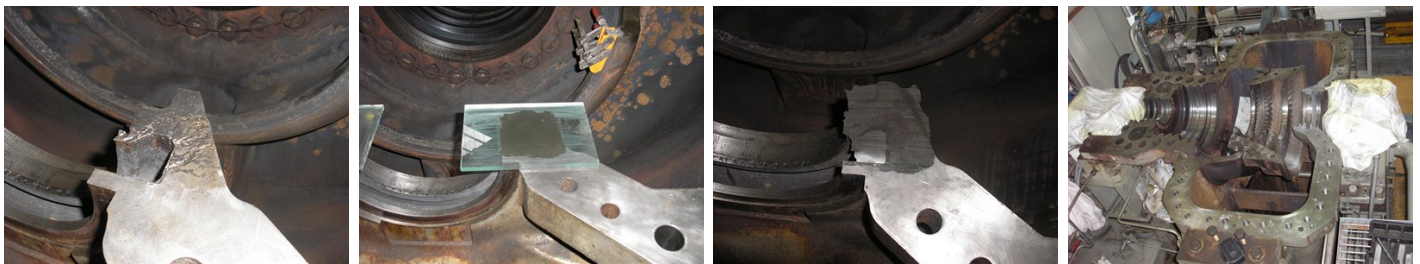
Wet steam caused erosion corrosion damage to flange face of turbine casing. This damage meant steam leakage from the turbine.

- * 1. Damaged turbine split casing ,
- * 2. Glass panel (coated with Belzona 9411 Release agent) used to form flat surface on Belzona ,
- * 3. Repaired area ,
- * 4. Turbine ready for mounting ,

Application was carried out in accordance with Belzona Know-How System Leaflet ENC-7.
