Lorry Engine Repaired with Belzona

ID: 7576

Customer Location: *Transport company, Slovakia*
Application Date: *2014*

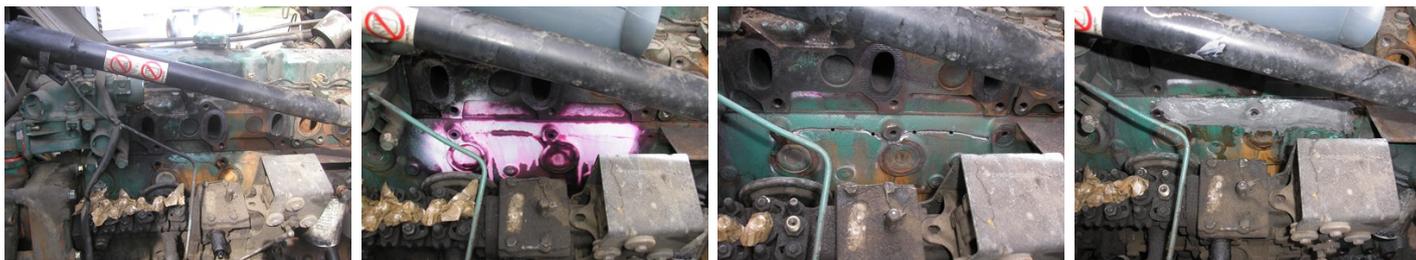
Cracked block due to freezing over winter months.

- * 1. Cracked engine ,
- * 2. Crack detection to identify all cracks ,
- * 3. Surface preparation ,
- * 4. Belzona 1111 repair incorporating Belzona 9341 Reinforcement Tape. ,

Welding of this damage would take a long time and potentially cause more damage so repairing with Belzona 1111 was much better for customer.
