BELZONA REPAIRS A GATE VALVE CRACK

ID: 7624

Application: VPF-Valves, Pipes and Fittings

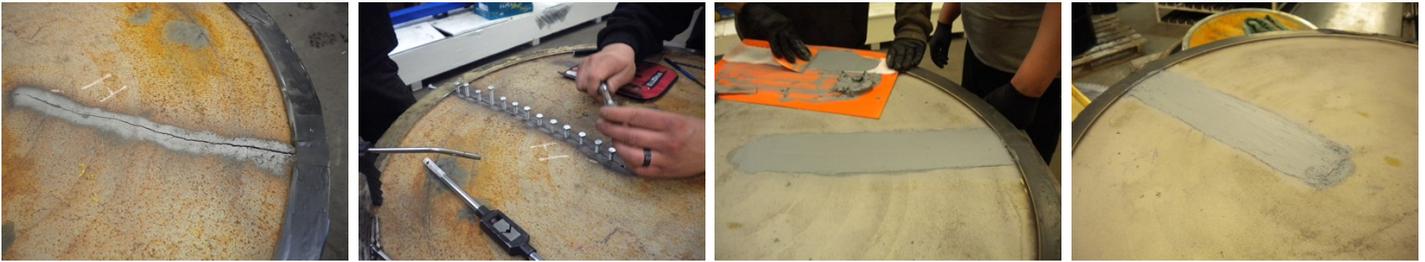
The disk of the gate valve had a large crack extending from the seat rings on the edge to the center of the disk.

- * 1. Crack in disk of gate valve ,
- * 2. Holes drilled, tapped and studs inserted. Crack terminated. ,
- * 3. Reinforcement sheet incorporated to add strength. ,
- * 4. Completed application. ,

The application was carried out in accordance with Belzona Know-How System Leaflet VPF-8. Procedure was followed out on both sides of the disk.

Due to the composition of the ductile iron welding would have been difficult. Welding also would have introduced heat stresses as well as the potential for galvanic corrosion. ABS approved this method to get the vessel back in water with minimal downtime.
