# BELZONA REPAIRS A GATE VALVE CRACK

ID: 7624

36" gate valve on a crane ship.

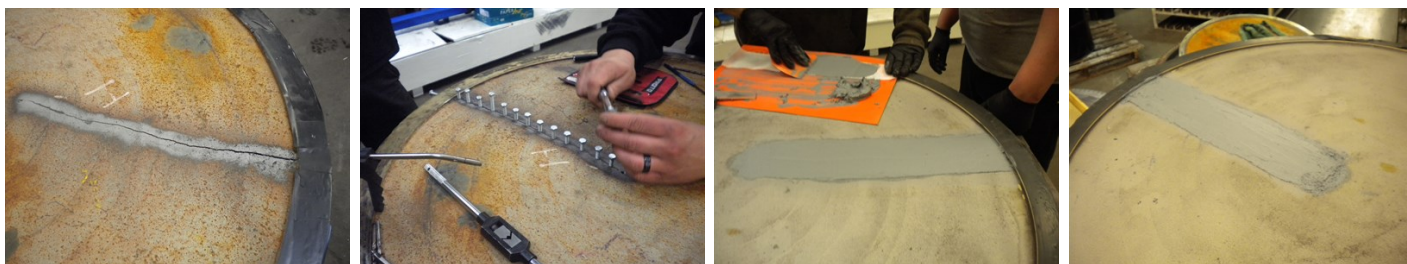
The disk of the gate valve had a large crack extending from the seat rings on the edge to the center of the disk.

- \* 1. Crack in disk of gate valve ,
- \* 2. Holes drilled, tapped and studs inserted. Crack terminated. ,
- \* 3. Reinforcement sheet incorporated to add strength. ,
- \* 4. Completed application. ,

The application was carried out in accordance with Belzona Know-How System Leaflet VPF-8. Procedure was followed out on both sides of the disk.

Due to the composition of the ductile iron welding would have been difficult. Welding also would have introduced heat stresses as well as the potential for galvanic corrosion. ABS approved this method to get the vessel back in water with minimal downtime.
