# Belzona SuperWrap Allows Drilling to Continue

ID: 7630

Industry: Oil & Gas  
Application: SOS-Ships and Offshore Structures

Customer Location: Azerbaijan  
Application Date: November 2017

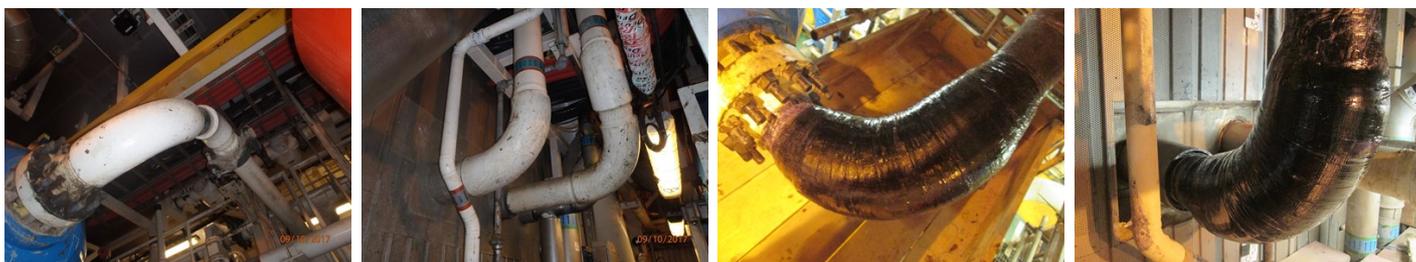
- \* 1. View of Pipe before 21 wraps ,
- \* 2. View of Pipe before 12 wraps ,
- \* 3. View of SuperWrap repair: 21 wraps ,
- \* 4. View of SuperWrap repair: 12 wraps ,

A platform off the coast of Baku had to stop drilling due to wall loss on the HP mud lines. The problem areas were on 3 bend sections.

Due to long lead time fabricating new sections of pipe, Belzona SuperWrap was used to reinstate the required strength to keep the high pressure lines in operation for at least 1 year.

Drilling needed to commence immediately and due to long lead time to replace the pipe sections, Belzona SuperWrap was able to give the required up time.
