Transformer Damaged by a Forklift Repaired with Belzona

ID: 7672

Electrical transformer cooling fin damaged by a forklift at a local recycling center.

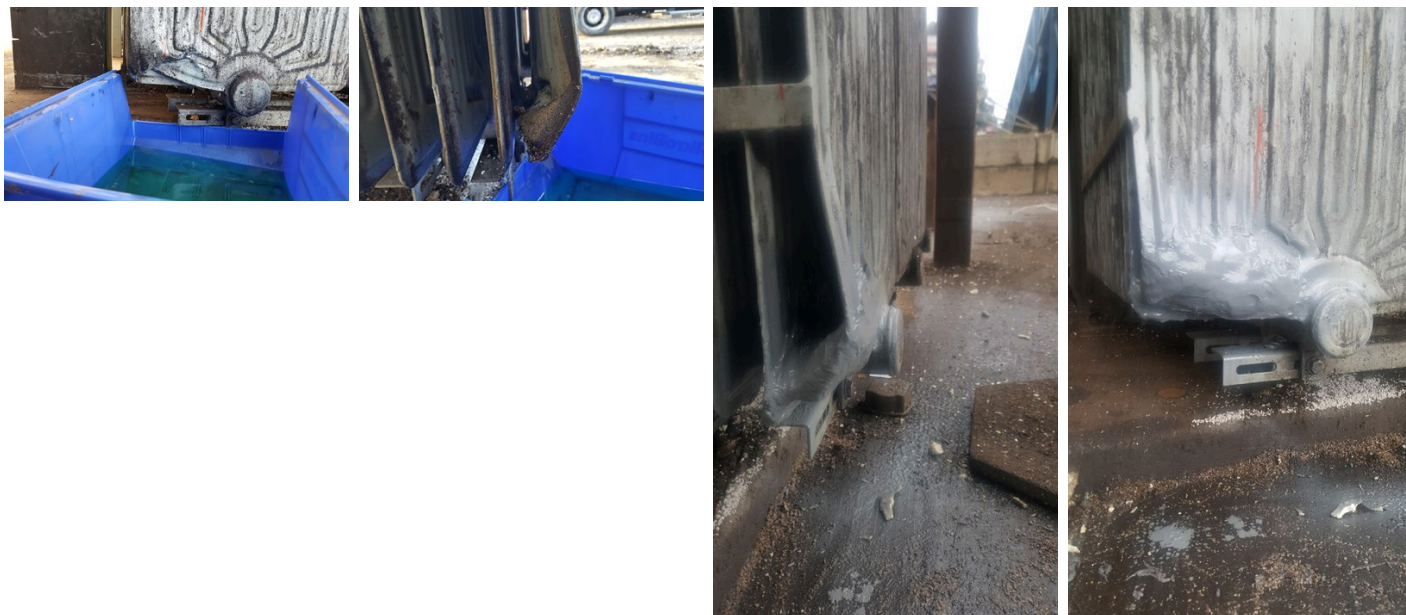
Forklift hit the cooling fins on an electrical transformer causing a serious oil leak.

- * 1. Note the oil dripping. ,
- * 2. Damage is severe, bending the cooling fin. ,
- * 3. & 4. Belzona 1212 applied, repair complete. ,

The trained Belzona contractor received a call about a leaking transformer. The caller was happy to hear that Belzona would be used for the repair as they had been a Belzona user for some time. The contractor tried doing a live leak repair but the oil was coming out too fast. Next he hooked up a vacuum pump to the transformer pulling about -5 pounds. This stopped the oil flow, Belzona 1212 was applied for a permanent repair.

The only alternative would have been to drain the oil from the transformer and replace the cooling fin. Due to the age of the transformer a replacement was not likely.
