Belzona 1311 Salvaged a Cracked Lining on a Valve

ID: 7794

Customer Location: Ireland, UK
Application Date: September 2018

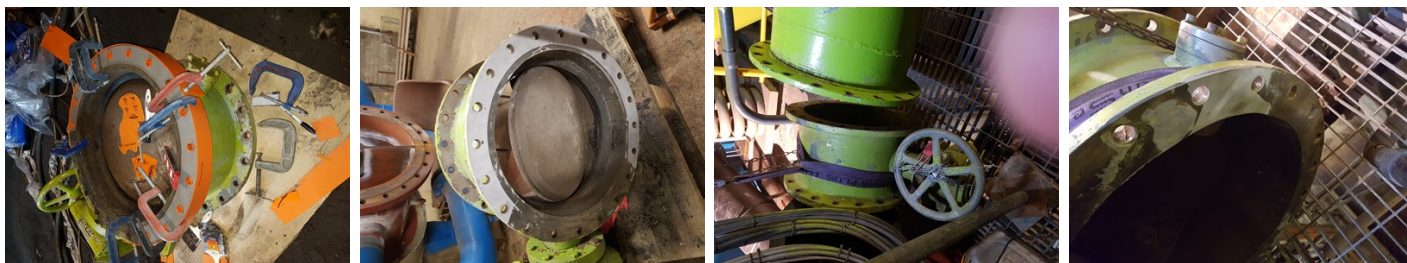
The ebonite lining on a valve from the auxillary cooling water system had cracked and failed around the valve flange

- * Substrate blasted and formers in position. ,
- * Repaired vlave ready to be installed. ,
- * Valve being installed. ,

The damaged ebonite liner was removed. The exposed steel was washed and grit blasted. Using a modified version of Belzona Know-How System leaflet GSS-10, formers were made from Belzona working surfaces and clamped into position. Belzona 1311 was applied and following curing the formers were removed.
