Belzona Repairs Worn Out Fan Shaft

ID: 7877

Customer Location: *Egypt*

Application Date: *March 2012*

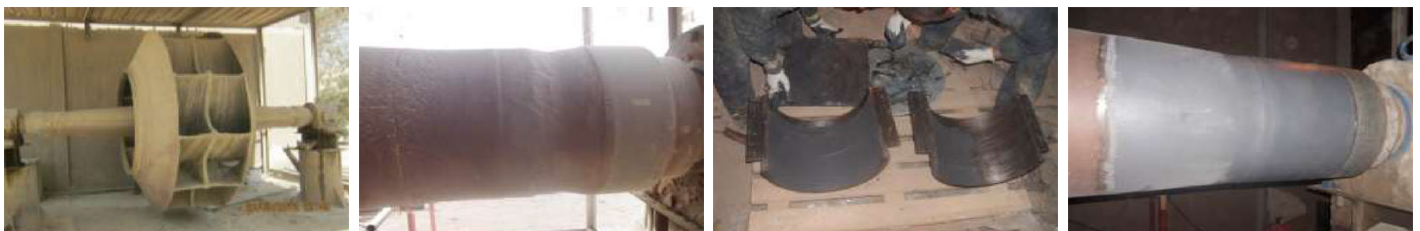
Deeply worn out due to abrasion in Fan shaft due to abrasion and bearing seizure which prevented the equipment from operating efficiently.

- * General view of the fan shaft. ,
- * Wear area in fan shaft. ,
- * Fabricated former to get the required dimensions. ,
- * Application complete. ,

A Fan shaft had failed due to abrasion from the process, and the bearings had seized in service.

The application was carried out in accordance with a modified version of Belzona Know-How System Leaflet MPT-2 for rebuilding damaged shafts using forming techniques. The area was prepared using a disk grinder to roughen the surface and to make a cross-hatching pattern on the surface. A coat of Belzona 9411 was applied to the inside of the formers, and the edges where material will be pushed out. Belzona 1111 was applied to the shaft and covered the entire area using a brush and the mixing spatula to apply the product. Also, the inside of the formers were covered and evenly spread. The formers were clamped to the shaft. Once Belzona 1111 had cured the former was removed.
