Belzona Repairs Grayloc Flange Damage in Water Injection Line

ID: 7967

Customer Location: Ghana, FPSO
Application Date: March 2019

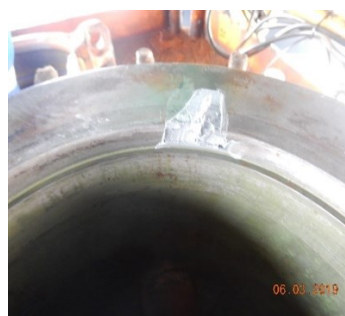
The topside end fitting connection joint on the riser used a Grayloc system to contain the high pressure. Due to a material defect a small area on the gasket had worn away, causing a leak.
