Belzona Chocking Repair on Gear Mounting

ID: 8061

Customer Location: Szarbków, Poland

Application: GSS-Gaskets, Seals and Shims

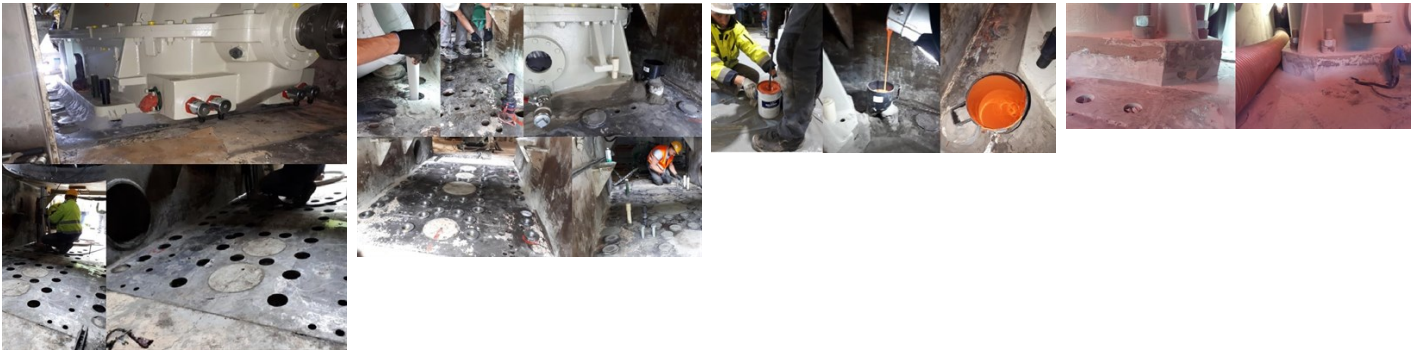
Gear mounting not working at full efficiency due to misalignment. Repair work need to concrete area prior to chocking.

- * 1. Gear Equipment Picture ,
- * 2. Application of Belzona 4111 ,
- * 3. Application of Belzona 7111 ,
- * 4. Chocking application complete. ,

The application was carried out in accordance with Belzona System Leaflet GSS-2. Placing of the steel foundation slab using the Belzona 4111. Chocking the foundation of the mill plate using Belzona 7111.
