Belzona Chocking Repair on Gear Mounting

ID: 8061

Customer Location: Szarbków, Poland

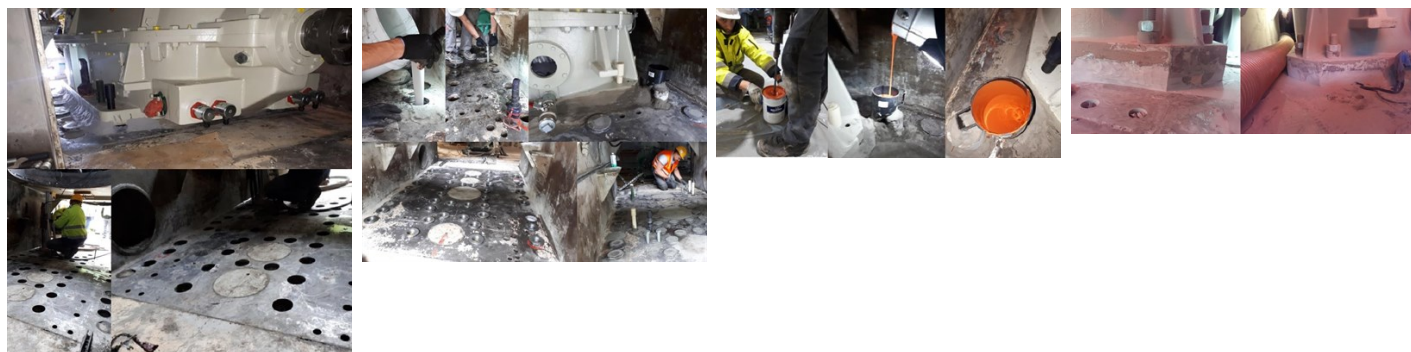
Gear mounting not working at full efficiency due to misalignment. Repair work need to concrete area prior to chocking.

- * 1. Gear Equipment Picture ,
- * 2. Application of Belzona 4111 ,
- * 3. Application of Belzona 7111 ,
- * 4. Chocking application complete. ,

Re-levelling a steel foundation slab of a mill gear and the foundation of the mill on the plate.

The application was carried out in accordance with Belzona System Leaflet GSS-2. Placing of the steel foundation slab using the Belzona 4111. Chocking the foundation of the mill plate using Belzona 7111.
