Repair Of Cavitation Damage on Impeller

ID: 8299

Customer Location: Shipyard, TURKEY
Application Date: February 2020

Impeller of Seawater Pump

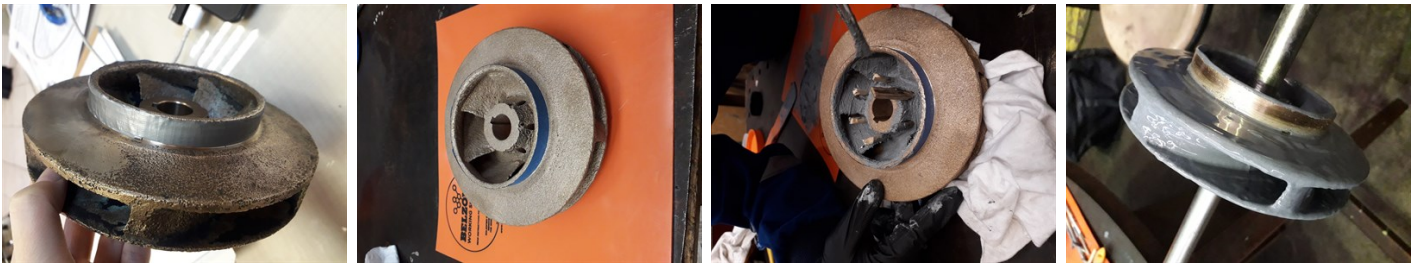
Due to cavitation damage of seawater, impeller has pitting damages on surface and blades causing low efficiency pumping.

- * Cavitation damaged surface ,
- * After surface preparation ,
- * Application of Belzona 1111 ,
- * Application of Belzona 1321 ,

Application was carried out in accordance with Belzona Know-How System Leaflet SOS-01 and SOS-02. Application surface was prepared with SA2½ grit blasting in workshop. Surface the cleaned with Belzona 9111. Belzona 1111 was used to repair the damaged impeller surface. Belzona 1321 was applied on top of Belzona 1111 and impeller surface within overcoating window, without the need of additional surface preparation.
