# MAINTENANCE OF BELZONA COATED SEPARATOR AFTER 9 YEARS IN SERVICE

ID: 835

Customer Location: North Sea Platform, UK  
 Application Date: Nov 1997

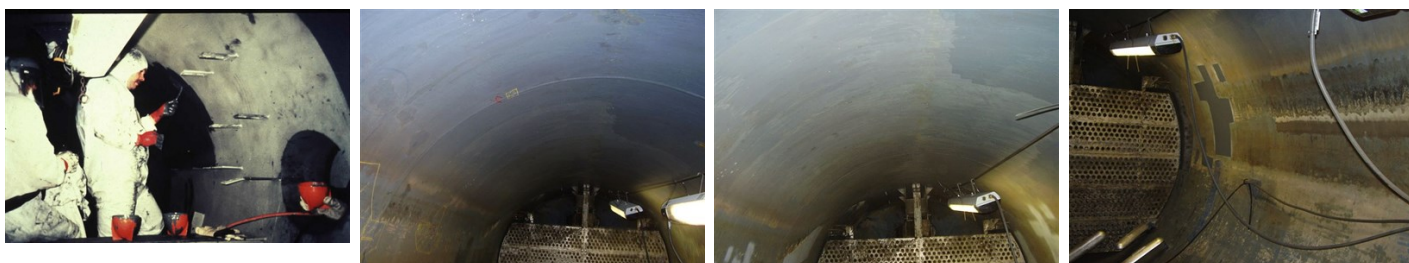
Previous glass flake system had failed and had suffered corrosion damage to the vessel wall. Belzona inspected after 9 years and only problems caused by local areas of mechanical damage.

- \* Vessel being coated in 1997. ,
- \* Vessel inspection in 2006. ,
- \* Vessel Inspection 2006. ,
- \* Localised Repair 2006. ,

After 9 years in service, the vessel was returned to service with only the need for localized repairs.
