MAINTENANCE OF BELZONA COATED SEPARATOR AFTER 9 YEARS IN SERVICE

ID: 835

Customer Location: North Sea Platform, UK
 Application Date: Nov 1997

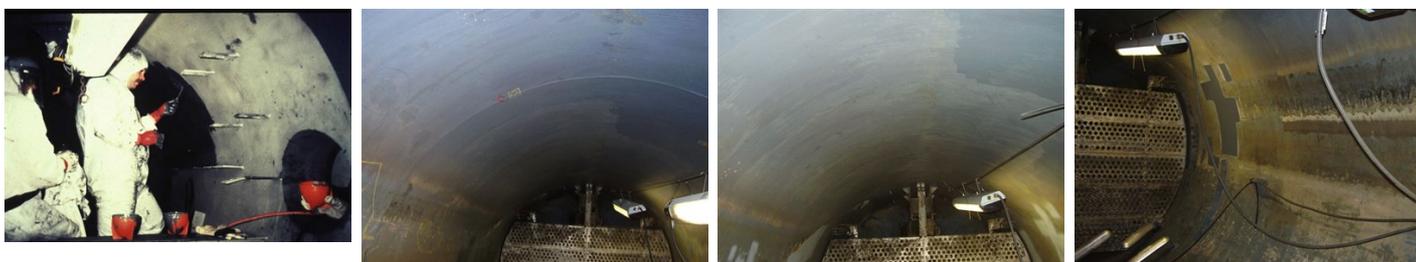
Previous glass flake system had failed and had suffered corrosion damage to the vessel wall. Belzona inspected after 9 years and only problems caused by local areas of mechanical damage.

- * Vessel being coated in 1997. ,
- * Vessel inspection in 2006. ,
- * Vessel Inspection 2006. ,
- * Localised Repair 2006. ,

After 9 years in service, the vessel was returned to service with only the need for localized repairs.
