# CAVITATION DAMAGE IN PUMP REPAIRED

ID: 837

Industry: Power  
Application: CEP-Centrifugal Pumps  
Substrate: Cast carbon steel (5% Nickel)  
Products: \* Belzona® 1221 (Super E-Metal) ,  
\* Belzona® 2141 (ACR Elastomer) ,

Customer Location: Power Plant / NE Oklahoma  
Application Date: March 2007

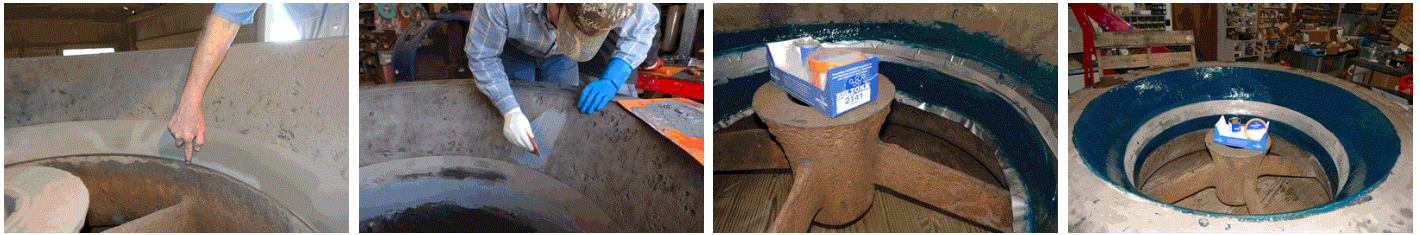
Severe cavitation erosion above and below wear ring. limited time to restore pump.

- \* Extent of cavitation damage to suction bell, above and below wear ring ,
- \* Repairing damage back to original dimensions ,
- \* Repaired surface rebated, taped and half coated with Belzona® 2141 ,
- \* Finished job ready for bushing installation then into service ,

Application carried out in accordance with Belzona Know-How System Leaflets CEP-3 and CEP-5. Rebate grooves were cut to terminate coating.
