Восстановление посадочного места под подшипник на валу вентилятора

ID: 8401

Вал Высокопроизводительного Вентилятора Сушильного Аппарата Солодовни

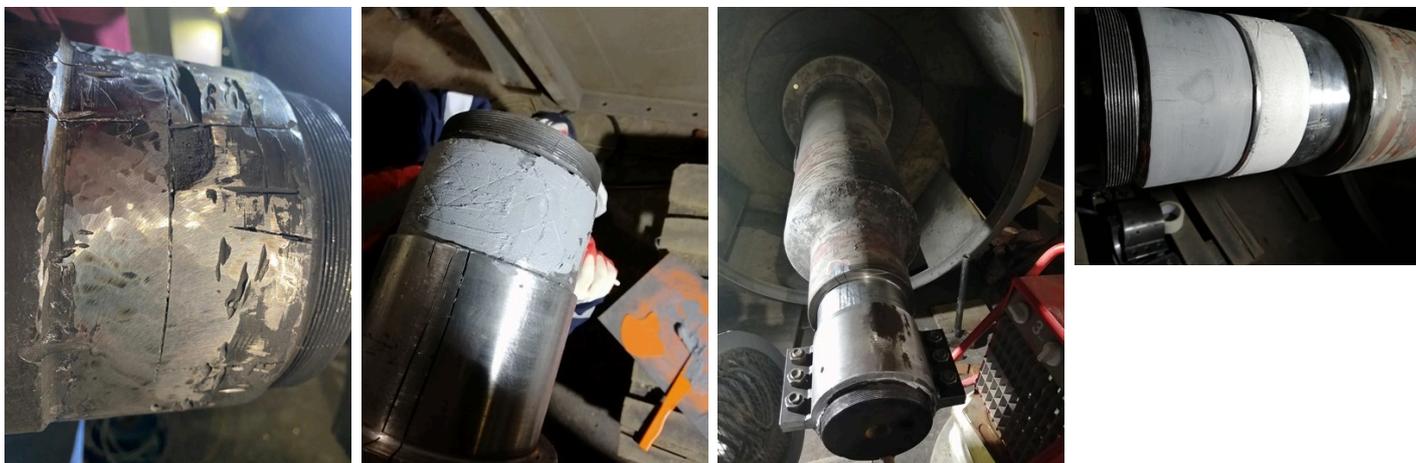
В процессе эксплуатации оборудования вышел из строя подшипник. Обойму подшипника провернуло, что привело к повреждению вала.

- * 1. Поврежденный вал ,
- * 2. Подготовка поверхности и нанесение материала Belzona 1111 ,
- * 3. Установка оправки ,
- * 4. Внешний вид восстановленного вала ,

Ремонт был проведен в соответствии с системными листовками Belzona MPT-2.

Из за простоя оборудования завод нёс многомиллионные убытки. Ремонт произведен в течении

двух дней с учетом изготовления оправки.
