Восстановление посадочного места под подшипник на валу вентилятора

Местоположение Пивоваренный завод
клиента: г.Казань, Республика
Татарстан

Вал Высокопроизводительного Вентилятора Сушильного Аппарата Солодовни

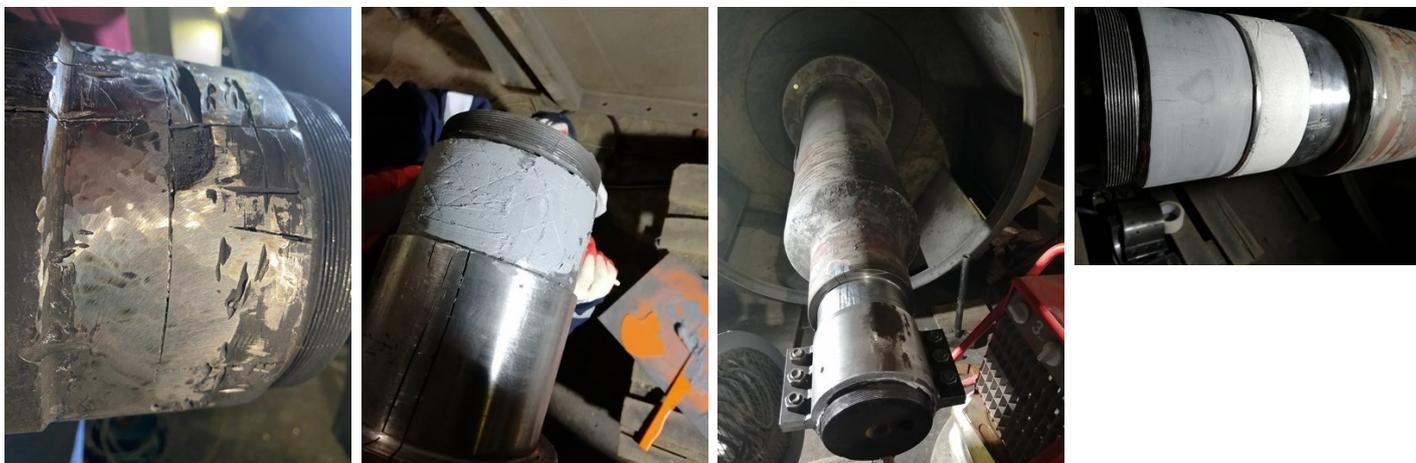
В процессе эксплуатации оборудования вышел из строя подшипник. Обойму подшипника провернуло, что привело к повреждению вала.

- * 1. Поврежденный вал ,
- * 2. Подготовка поверхности и нанесение материала Belzona 1111 ,
- * 3. Установка оправки ,
- * 4. Внешний вид восстановленного вала ,

Ремонт был проведен в соответствии с системными листовками Belzona MPT-2.

двух дней с учетом изготовления оправки.
