Emergency Flange Repair

ID: 8523

Industry: Marine

Application: VPF-Valves, Pipes and Fittings

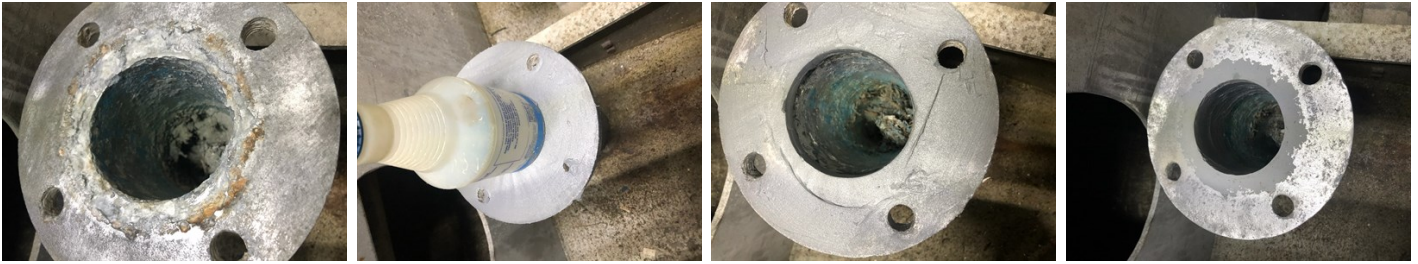
Erosion of the flange face caused ineffective sealing surface

- * 1) Before application ,
- * 2) Casting process ,
- * 3) Cast removed ,
- * 4) Flange sanded and ready to re-install ,

Rebuild flange face using a plastic bottle as a cast

Prepared steel with wire wheel and angle grinder. De-greased and then scrubbed Belzona 1111 onto flange, building up pitted area. Applied Belzona 9411 to plastic bottle. Pressed Belzona 1111 into void around bottle. Sanded excess material back to original dimension.
