ENGINE REPAIR WITH BELZONA

Customer Location: Limestone producer, Troy, MO

Application: ENC-Engines and Casings

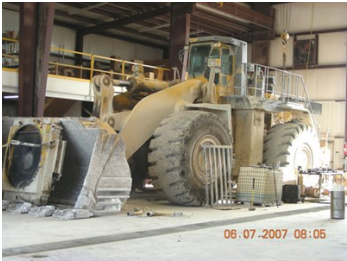
* Komatsu 900 loader , * Typical damage , * Completed surface preparation , * Finished repair to 1 of the 11 damaged areas ,

Komatsu 900 loader.

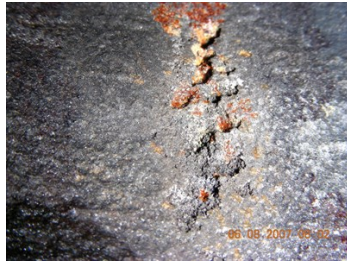
Erosion/corrosion on the cylinder block behind the cylinder liners allowed engine coolant to leak into the lubricating oil causing an engine failure.
