Belzona helps a manufacturer of aeroplane components

ID: 8542

Application: CEP-Centrifugal Pumps

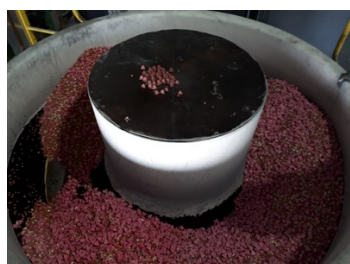
Severely damaged rubber linings. Presence of three cracks after surface preparation.

- * 1 : Damaged rubber linings ,
- * 2 : Cracks repair with Belzona 1111 (Super-Metal) and Belzona 9341 (Reinforcement Tape) ,
- * 3 : Application of first coat of Belzona 2141 (ACR-Fluid Elastomer) with the Reinforcement Tape Belzona 9341 ,
- * 4 : Completed application ,

During inspection, localised damage to the rubber linings caused by wear and abrasion was noted
