# crack repair of a gas engine power generator with Belzona

ID: 8554

Application: ENC-Engines and Casings

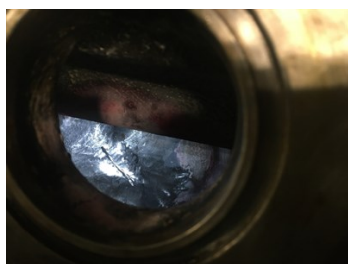
The crack was found deep inside the GE Jenbacher gas engine. The area to be repaired was difficult to access and the regular surface preparation (SA2,5 and 75 microns) was not an option.

Grinding using a small size electric rotary file was followed by a cleaning and degreasing with 9111 prior the application of the mixed 1212. The paste has been applied with a Belzona spatula through an 80mm (3,15") diameter exhaust hole while another colleague controlled and directed from the other side of the engine.
