CATERPILLAR 631 ENGINE REPAIRED WITH BELZONA

ID: 856

Customer Location: Magruder Limestone Company, Troy MO
Application Date: June 2007

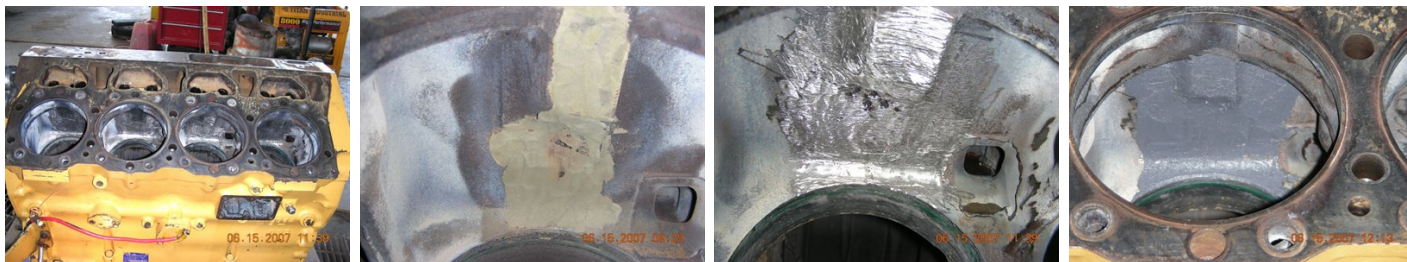
A previous repair with "Brand X" epoxy failed. The owner took it to his own shop & did the work.

* Caterpillar 631 engine block , * Failed "Brand X" repair , * Prepared surface on 1 of the cylinders showing leaks , * Completed repair on 1 cylinder ,

Traces of engine coolant appeared in the lubricating oil test samples indicating erosion in wall of cylinder block

Application carried out in accordance with Belzona Know-How System Leaflet ENC-6.

This is a Caterpillar approved repair for a cavitated engine blocks and has been successfully completed many times on these and Komatsu engines. The Cat dealer declined to do the Belzona repair, claiming that the "brand X" failed repair proved that another such repair couldnt be done & wanted to sell a new engine block.
