Pump case erosion damage repair in gravel mine

ID: 8589

Application: CEP-Centrifugal Pumps

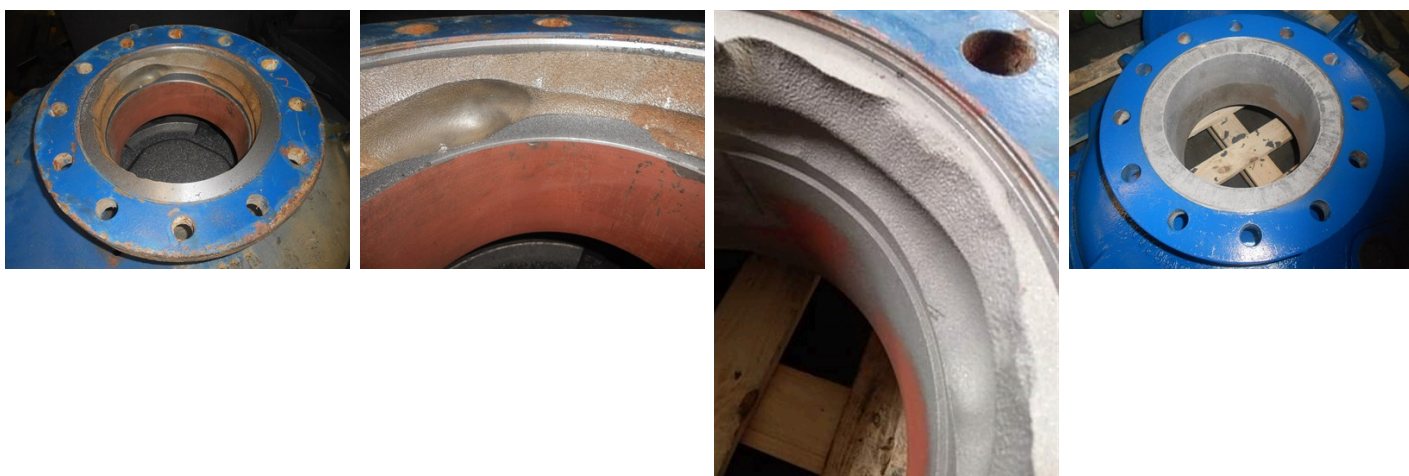
The customers Warman WGR200 suffered from erosion because of the failure of the rubber lining the entrapped solid in the flow found route to the casing surface. The casing material wore until leakage.

- * 1-Defective casing ,
- * 2-Defective area ,
- * 3-Defective area after sand blasting ,
- * 4-Finished application with 1321 top-coat ,

Products: * Belzona 1812 was used to build up the whole material loss and subsequently a coat of Belzona 1321 was applied to smooth out the surface, this combination is the best possible solution to prevent or to slow down this erosion mechanism. ,

Hand application according to the CEP-06: For repair of holed/cracked casings
