TURNTABLE TROUBLE SORTED WITH BELZONA

ID: 859

Worn Spline and Gear Drive

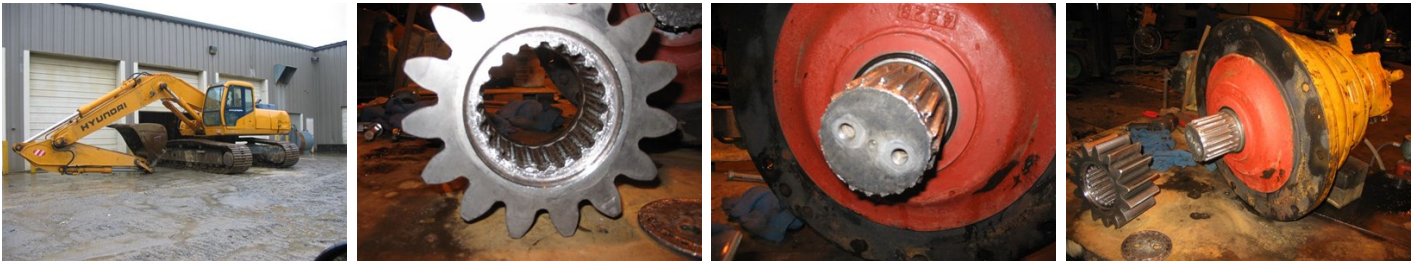
Spline drive and gears were so old and worn that the main deck turntable on the excavator could not operate.

* Excavator unable to rotate Worn gear Worn drive Worn gear and drive ,

Application was carried out in accordance with Belzona System leaflet MPT-5.
