# TURNTABLE TROUBLE SORTED WITH BELZONA

ID: 859

Industry: Mining & Quarrying  
Application: MPT-Mechanical Power Transmission

Customer Location: Heavy Equipment Repair Shop  
Application Date: May 2006

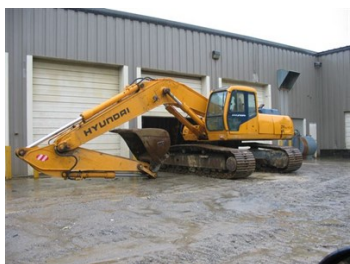
Spline drive and gears were so old and worn that the main deck turntable on the excavator could not operate.

\* Excavator unable to rotateWorn gearWorn driveWorn gear and drive ,

Application was carried out in accordance with Belzona System leaflet MPT-5.

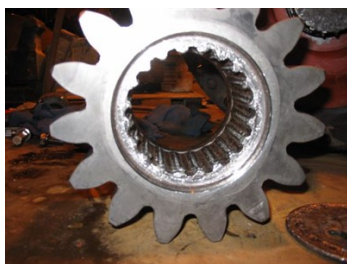
Worn Spline and Gear Drive
