Repair of damaged pump parts

ID: 9013

Application: CEP-Centrifugal Pumps

Customer Location: Jubail

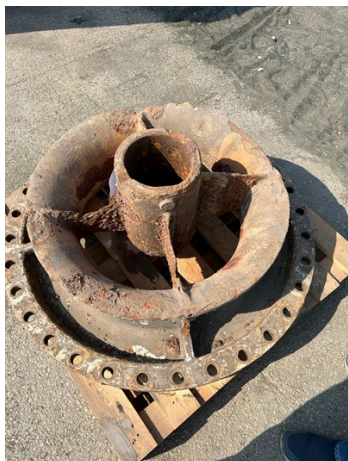
The pump part was heavily corroded and eroded and not in a condition to use

Initial condition

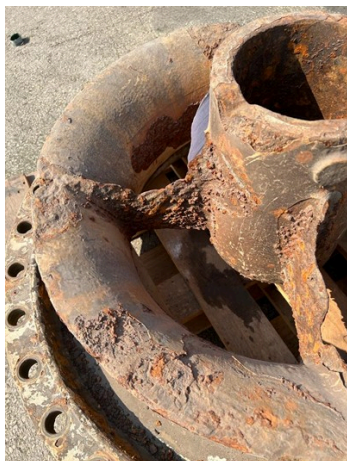
Initial Condition

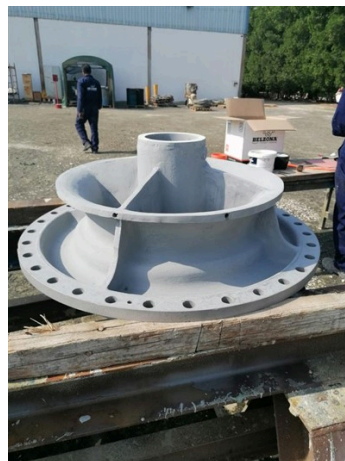
After repair with Belzona 1111

The application was completed in accordance with Belzona System Leaflets CEP 01, CEP 03 and CEP 05

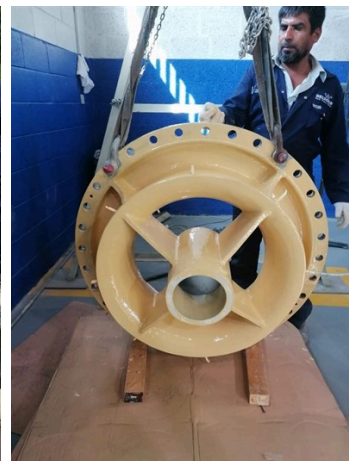
After coating with Belzona 5821
