Repair of damaged pump parts

ID: 9013

Industry: Oil & Gas
Application: CEP-Centrifugal Pumps
Substrate: Carbon steel
Products: Belzona 1111 (Super Metal), Belzona 5821

Customer Location: Jubail
Application Date: November 2022

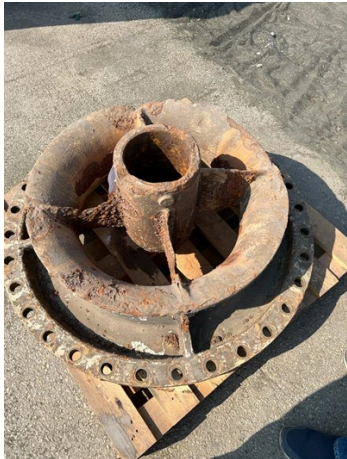
The pump part was heavily corroded and eroded and not in a condition to use

Initial condition

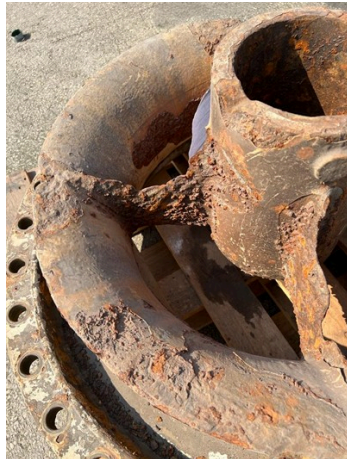
Initial Condition

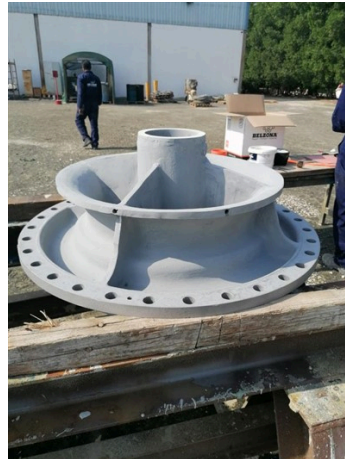
After repair with Belzona 1111

The application was completed in accordance with Belzona System Leaflets CEP 01, CEP 03 and CEP 05

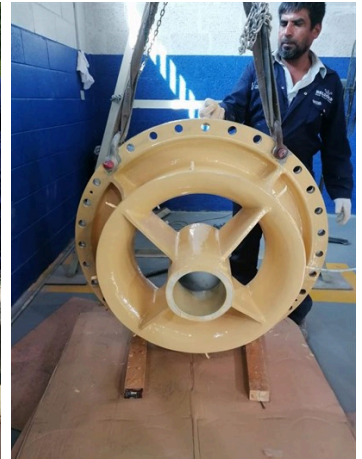
After coating with Belzona 5821
