# Broken Cast Aluminum Motor Cover Repair

ID: 9023

Industry: *Marine*  
Application: *ENC-Engines and Casings*  
Substrate: *Aluminum*  
Products: *Belzona 7311*

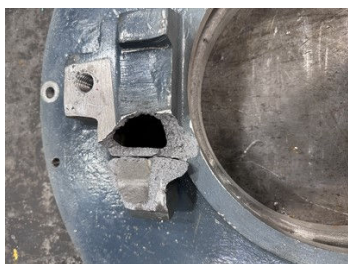
*Part of the cast aluminum motor cover was broken off. Welding, replacement and cold bonding were the options.*

Broken Piece
