Broken Cast Aluminum Motor Cover Repair

ID: 9023

Industry: Marine
Application: ENC-Engines and Casings
Substrate: Aluminum
Products: Belzona 7311

Customer Location: Seattle Washington
Application Date: March 2023

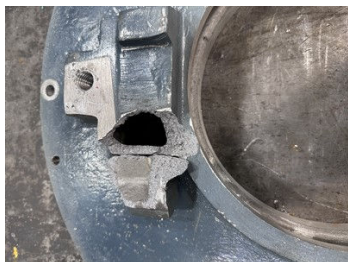
Part of the cast aluminum motor cover was broken off. Welding, replacement and cold bonding were the options.

Broken Piece

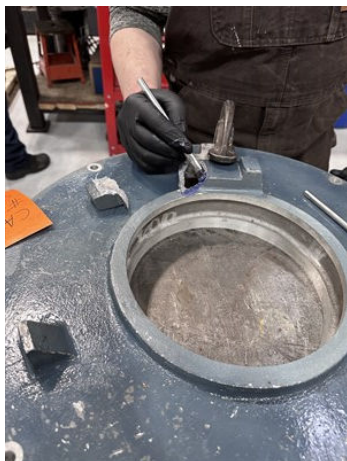
Applying 7311 to Cover

Mating surfaces were roughened and de-greased. 7311 was brushed into the substrate using a stiff bristled acid brush. Material was built up then broken piece was set in place and clamped during the curing process.

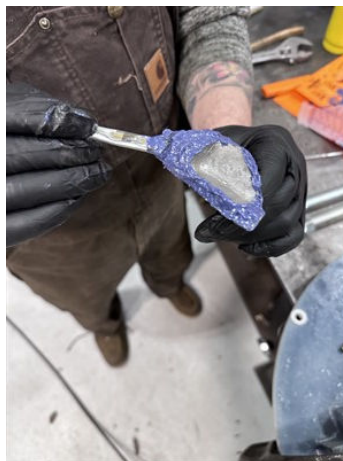
Applying 7311 to Broken Piece

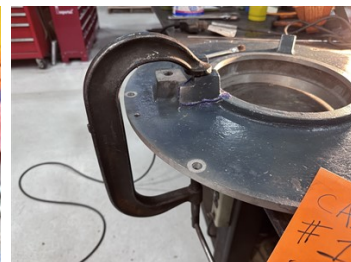
Completed Application
