Fractured GRP pipe repaired with Belzona Super Wrap 2

ID: 9033

Industry: Power
Application: VPF-Valves, Pipes and Fittings
Substrate: GFRP
Products: Belzona 1212, Belzona 1983 (SuperWrap II)

Customer Location: Ireland
Application Date: March 2023

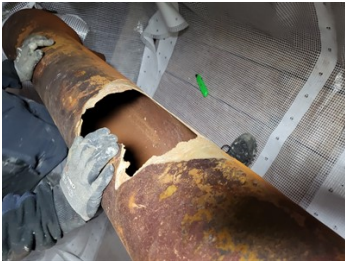
A GRP pipe had shattered causing a partial shutdown of a power plant

Fractured 8" GRP pipe

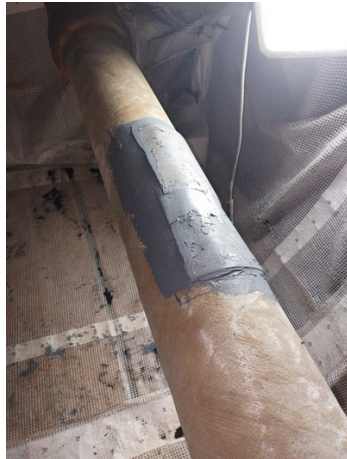
Steel plate bonded over the hole with Belzona 1212

The GRP was cleaned by grit blasting and a steel plate was bonded over the hole to act as a support for the reinforcing wrap

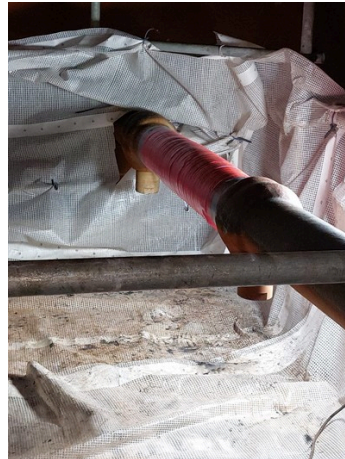
Damaged area reinforced using Belzona Super Wrap 2
