Fractured GRP pipe repaired with Belzona Super Wrap 2

ID: 9033

Industry: Power
Application: VPF-Valves, Pipes and Fittings
Substrate: GFRP
Products: Belzona 1212, Belzona 1983 (SuperWrap II)

Customer Location: Ireland
Application Date: March 2023

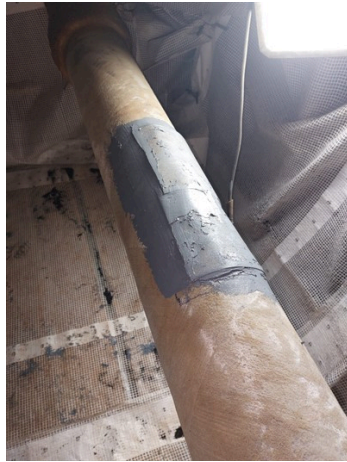
Steel plate bonded over the hole with Belzona 1212

The GRP was cleaned by grit blasting and a steel plate was bonded over the hole to act as a support for the reinforcing wrap

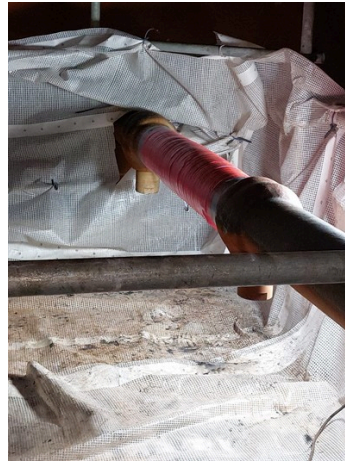
Damaged area reinforced using Belzona Super Wrap 2
