Belzona quickly saves the ripped conveyor belt

ID: 9044

Industry: Mining & Quarrying
Application: SHM-Solids Handling Machinery

Customer Location: Northern Croatia
Application Date: November 2022

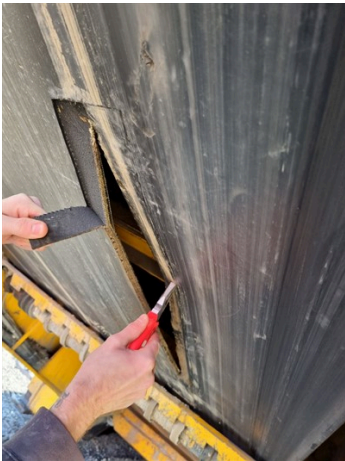
An incident in production caused damage to a conveyor belt. The belt was ripped through the middle in length of more than 1 m. The production had to stop.

Ripped conveyor belt

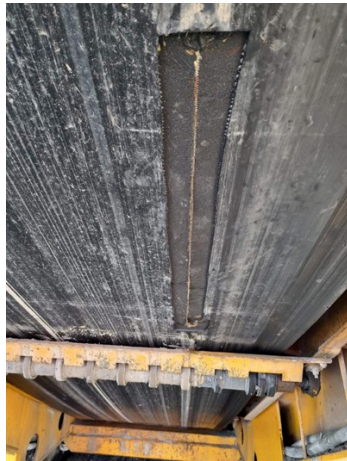
First layer of the belt peeled off in order to install belt fasteners properly

First we peeled off (delaminated) the first layer of the belt in order to install belt fasteners in the way then aren't above the belt level. Then we installed belt fasteners, abraded them with the grinder and applied Belzona 2911 and Belzona 2311.

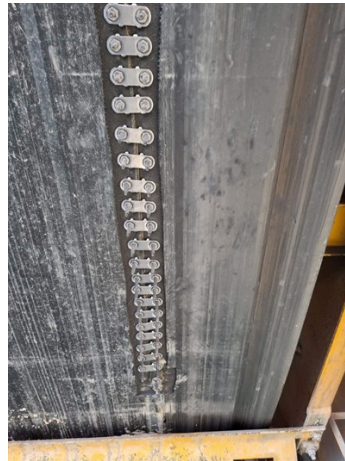
Belt fasteners installed

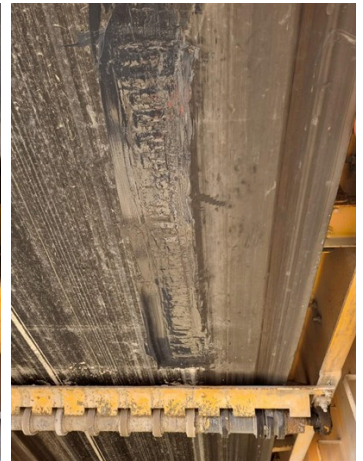
Belt fasteners protected with Belzona 2311
