Pump Oil Sump Not All Its "Cracked" Up To Be

Customer Location: US Bureau of Reclamation / Farmington, NM

Application: VPF-Valves, Pipes and Fittings

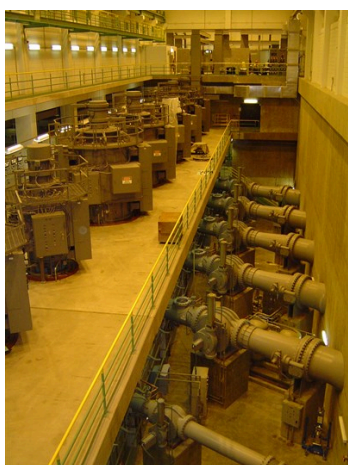
Large oil sump for the shaft bearing at the top of the pump was experiencing cracking from harmonic vibration. As the company that produced the pump was no longer in business and available parts are difficult to find and very expensive, \$1000 of Belzona saved them over \$60,000 worth of replacement parts, labor and downtime. In addition the Belzona solution eliminated the problem from occurring again.

* Pump Station , * Clean, Dry and Abraded , * Conditioner Applied , * Application of the Belzona® 2111 ,
