Axial flow pump rebuild & coating

ID: 9186

Customer Location: Scotland
Application Date: July 2023

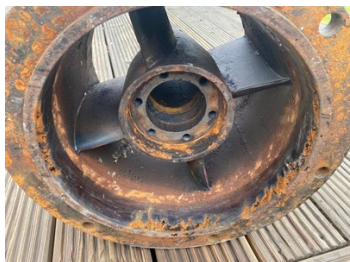
An axial flow pump had become damaged by erosion & corrosion in service leading to a loss in efficiency

Damaged pump body

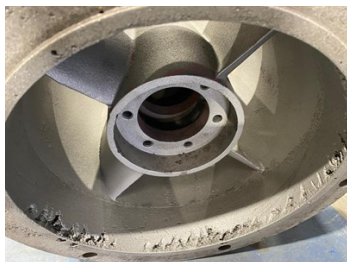
Surface preparation

The components were grit blasting to SA2.5 & 75 microns. Lost metal was rebuild with Belzona 1111 (Super Metal). Two coating of Belzona 1321 (Ceramic S Metal) were then applied.

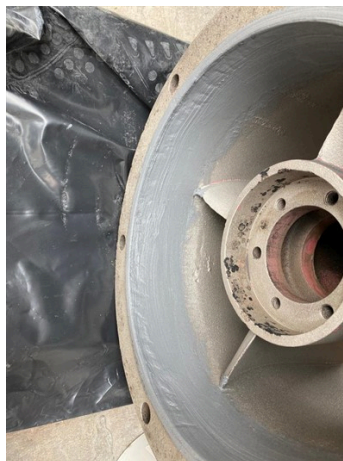
Rebuilding with Belzona 1111

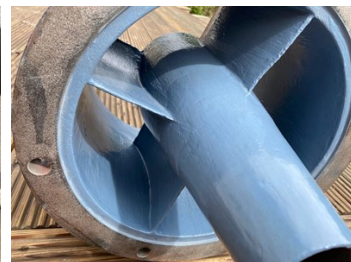
Finished Belzona coating

This repair & coating allowed the pump to go back into service, saving it from scrap & making it more resistant to erosion & corrosion than the original components.
