Axial flow pump rebuild & coating

ID: 9186

Industry: *General Industry*
Application: *CEP-Centrifugal Pumps*
Substrate: *Carbon steel*
Products: *Belzona 1111 (Super Metal), Belzona 1321 (Ceramic S-Metal)*

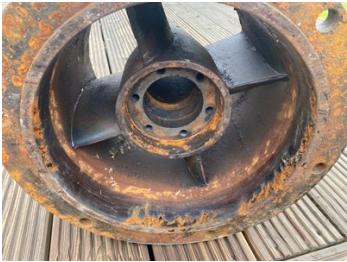
An axial flow pump had become damaged by erosion & corrosion in service leading to a loss in efficiency

Damaged pump body

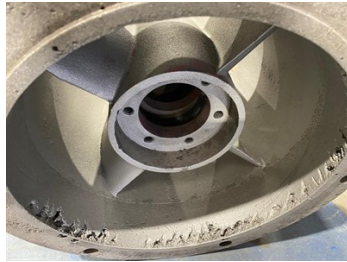
Surface preparation

The components were grit blasting to SA2.5 & 75 microns. Lost metal was rebuild with Belzona 1111 (Super Metal). Two coating of Belzona 1321 (Ceramic S Metal) were then applied.

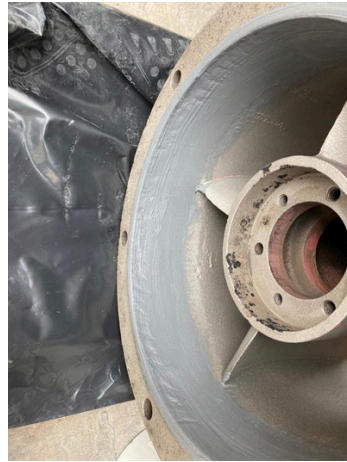
Rebuilding with Belzona 1111

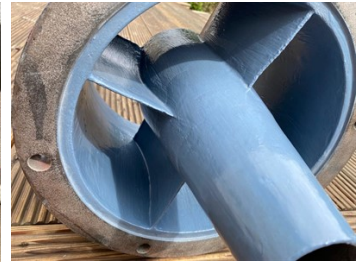
Finished Belzona coating

This repair & coating allowed the pump to go back into service, saving it from scrap & making it more resistant to erosion & corrosion than the original components.
