Metso Fly Ash Pump

ID: 9195

Industry: Power

Application: CEP-Centrifugal Pumps

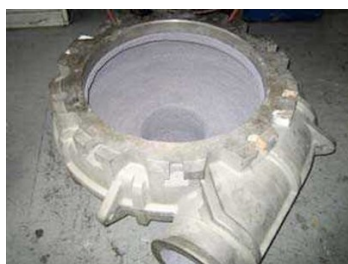
Rebuilding of casing

The pump impeller & casing were first grit blasted & then rebuilt using Belzona 1121. 3-6mm of Belzona 1812 was then applied to provide abrasion resistance.

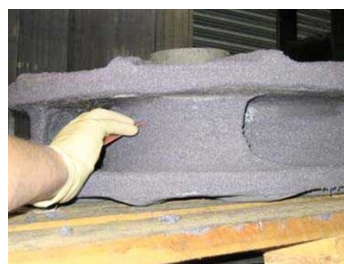
Impeller rebuild & lining
