Metso Fly Ash Pump

Industry: Power

Application: CEP-Centrifugal Pumps

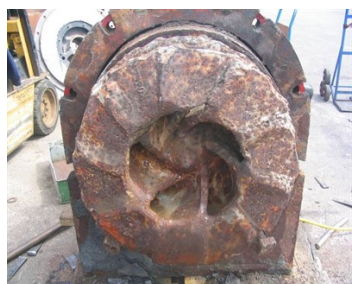
A pump used to transport fly ash was suffering severe erosion & corrosion in service. Due to the harsh conditions pump parts had to be replaced every 6 months.

Damaged parts after service
