# BELZONA REPAIRS A BROKEN HYDRO ELECTRIC TURBINE RUNNER

ID: 924

Customer Location: Hydro Electric Plant, U.S.A  
Application Date: May, 2007

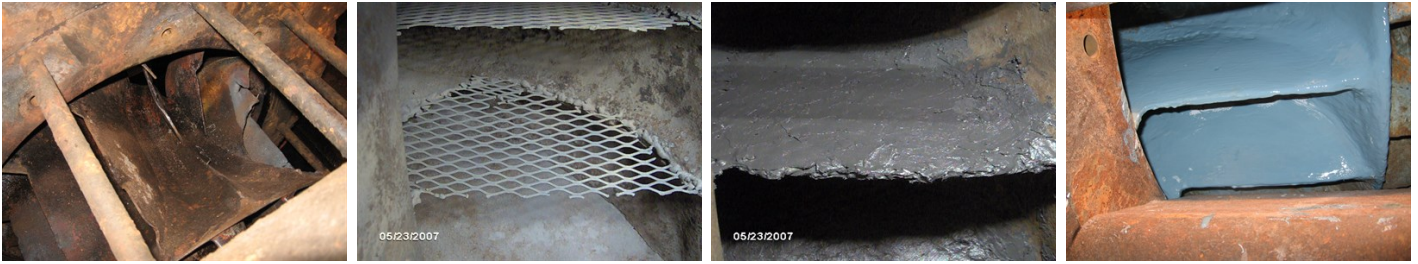
Loss of balance and horsepower.

\* Broken runner blade , \* Expanded metal tack welded , \* Blades rebuilt with Belzona® 1311 , \* Completed application after coating runner ,

Wicket gate came loose and fell into turbine breaking three blades on runner.

Application carried out in accordance with the Belzona Know-How System Leaflets CEP-1 & -3. Expanded metal was tack welded in place before rebuilding with Belzona® 1311. Complete runner then coated.
